Appendix C

Castle Point Borough Council

Prepared by Scott Wilson Ltd for The Thames Gateway South Essex Partnership

Appendix C – Castle Point Council

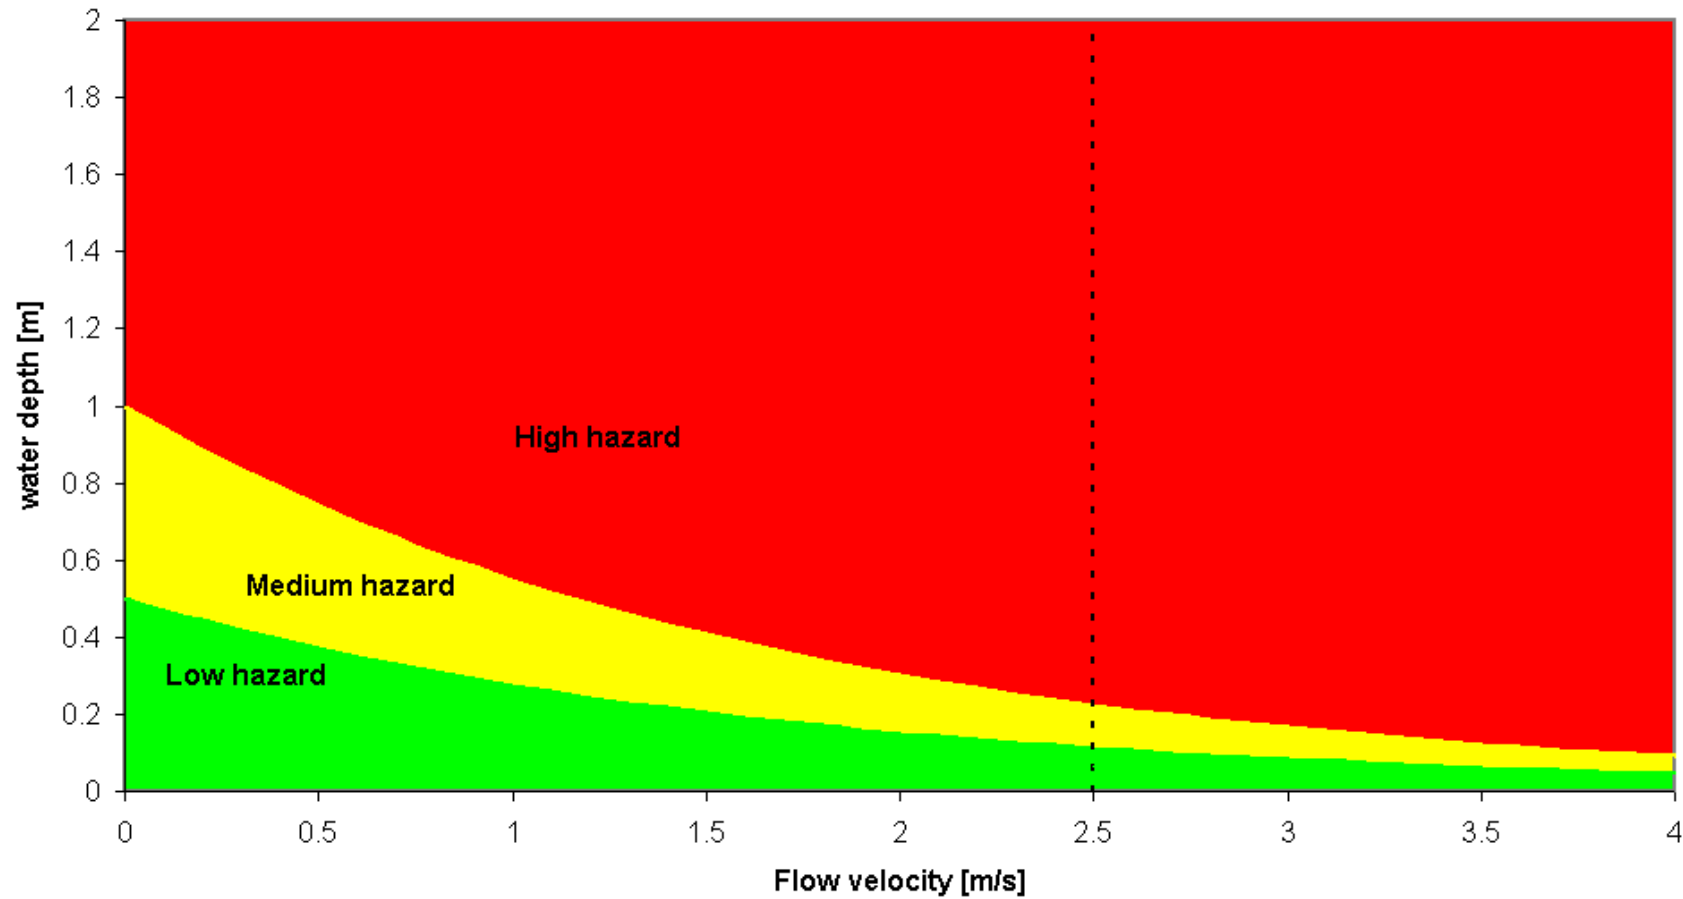
FIGURE 4-2 DEFINITIONS OF HAZARD ZONES

At the time of writing PPS25 was only available in Draft form however it is due for final publication in Autumn 2006. Guidance in relation to appropriate types of development in Flood Risk Zones is provided in Table D2 of Draft PPS25. Development types are grouped according to their vulnerability to flooding. It is vulnerability information such as this, which it is suggested is assessed with reference to Hazard Zones.

Definition of hazard zones
